Certificate and test report Nr. J147CON

Coupling system for solar thermal applications.
Test according to SPF test procedure: Test class A1

BEULCO SKS2
Fast coupling system for corrugated stainless steel pipes

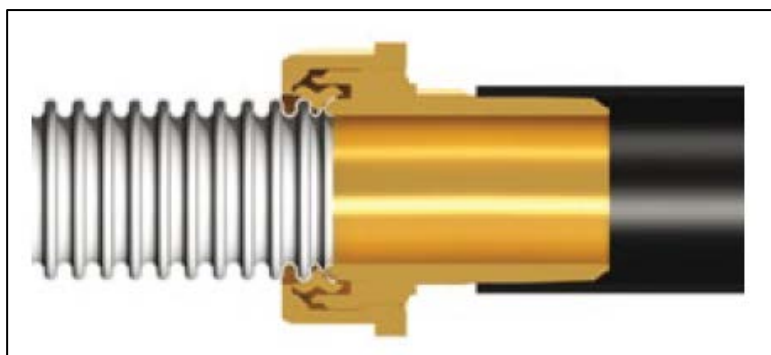
Fig. 1 Cross section of the mounted fitting system

Manufacturer:	Beulco GmbH & Co. KG
Model:	BEULCO SKS2
Tested sample(s):	SKS2
Connection Type:	Fast coupling system for corrugated pipes
Application range	Pipework for solar thermal installations.
Nominal fitting length:	n.a.
Nominal diameter(s):	DN16, DN20, DN25
Description of sample:	Metallic coupling system for connecting corrugated stainless steel tubes
Materials*	Screw-down nut CW617N; Clamping collar CW617N; Casing CW617 or CW602N
Heat transfer media*	not specified
Application limitations*	220 °C

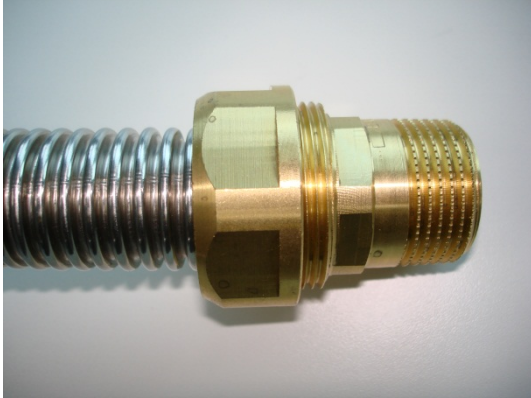
Figure 2: (before test start)
Fast coupling system before tightening.

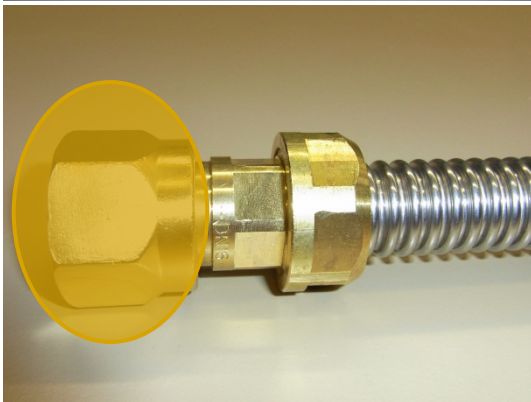
Figure 3: (before test start)
For the installation of the samples on the test rig additional adapters (orange circle) made by another manufacturer have to be applied. These un-plated brass adapters are not part of the test samples.

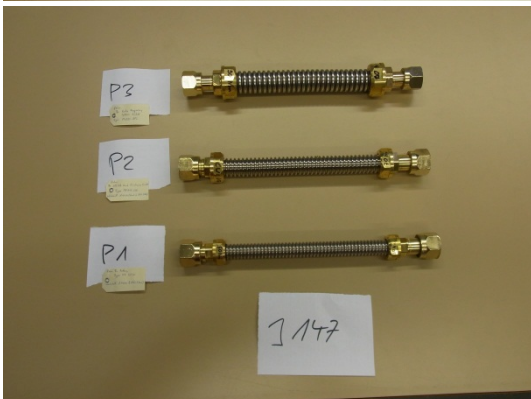
Figure 4: (before test start)
Three different sizes were tested using different brands of corrugated tubes.
P1: DN16 (Rattay HR I/S-W)
P2: DN20 (Solar Kurt Birnbreier, MF015 500)
P3: DN25 (Radio Frequency Systems, PW025-AFL)

Three pipe-work samples of different dimensions (DN16, DN20, DN25) each mounted to a different product of a corrugated stainless steel tube have been tested. The samples have been assembled by the manufacturer in a professional manner.

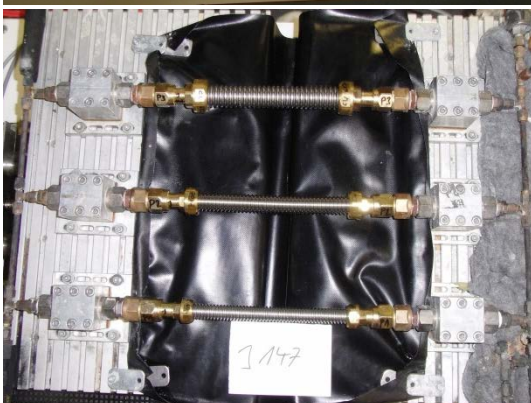
Figure 5: (before test start)
Test samples installed on the test rig.

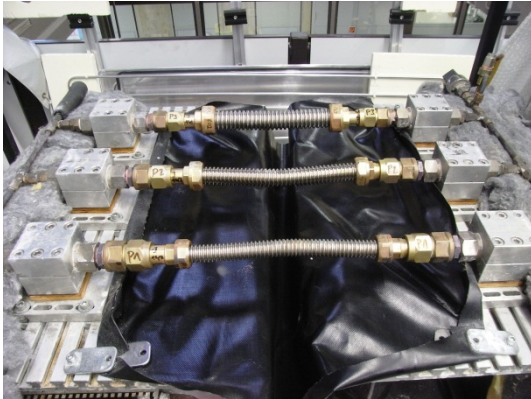
Figure 6: (after the test)

Tests samples on the test rig, after the test procedure has been accomplished. No leakage was observed. The deformation of the tubes is a result of the test procedure and does not affect the result of the test.

No leakage, deficiency and no other failures have been observed during the test. The “fast coupling system for corrugated stainless steel pipes” is therefore considered as suitable for the use in solar thermal installations.

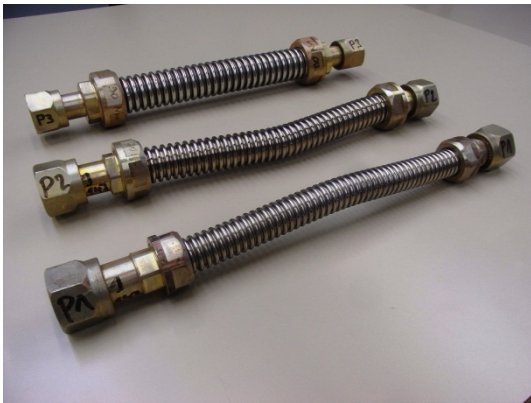
Figure 7: (after the test)

Test samples removed from the test rig. The deformation of the test tubes is permanent. No visible damage of the samples.

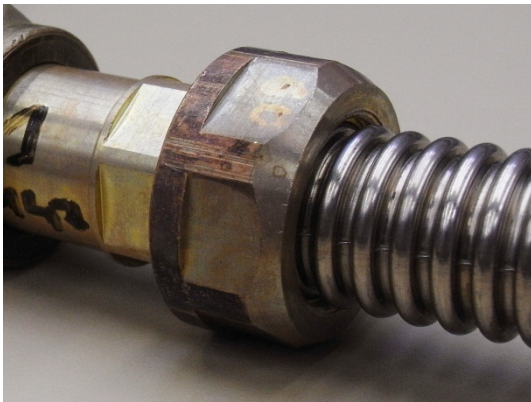
Figure 8: (after the test)

Close look at sample P1: DN16. Slight discoloration of the samples due to the permanent overheating. No signs of leakage

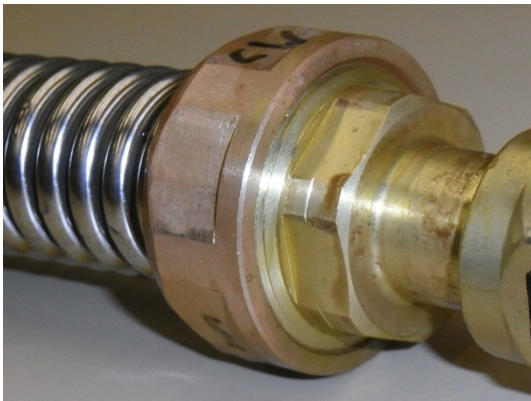
Figure 9: (after the test)

Close look at sample P3: DN25. Slight discoloration of the samples due to the permanent overheating. No signs of leakage.
